## Damage to vacuum pumps through incorrect assignment

<b>Vehicle:</b>	<b>Product:</b>	Vacuum pump
VW Transporter LT, T4 (pickup, window van, panel van, California) Engine code: AAB	<b>Pierburg No.:</b>	O.E.-No. :*)
	<b>7.22300.62.0</b>	075 145 100 ; 075 145 101; 075 145 101 A
	<b>7.22300.69.0</b>	074 145 100 A

Due to a change of the cylinder head in the case of the **VW T4 engine with engine code AAB** the vacuum pump has frequently been incorrectly assigned.

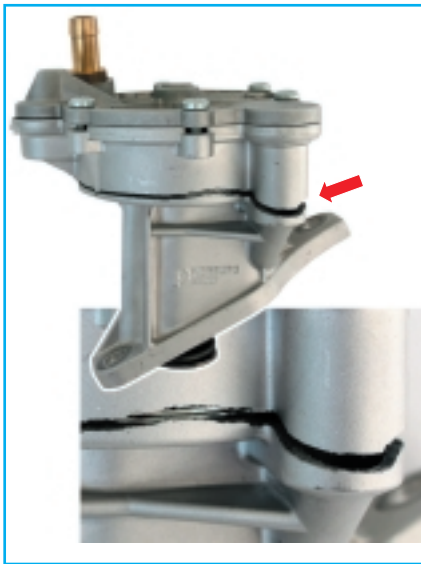
Mounting the wrong pump will „immediately“, upon starting the engine for the first time after installing the vacuum pump, cause the pump casing (see Fig. 1) to break or even the camshaft may break thereby resulting in severe and expensive engine damage.

Fig. 1 Broken pump casing

In order to prevent damage, a **precise check of the vehicle data** is essential.

We recommend to check in any case the assignment through the vehicle **identification number!**

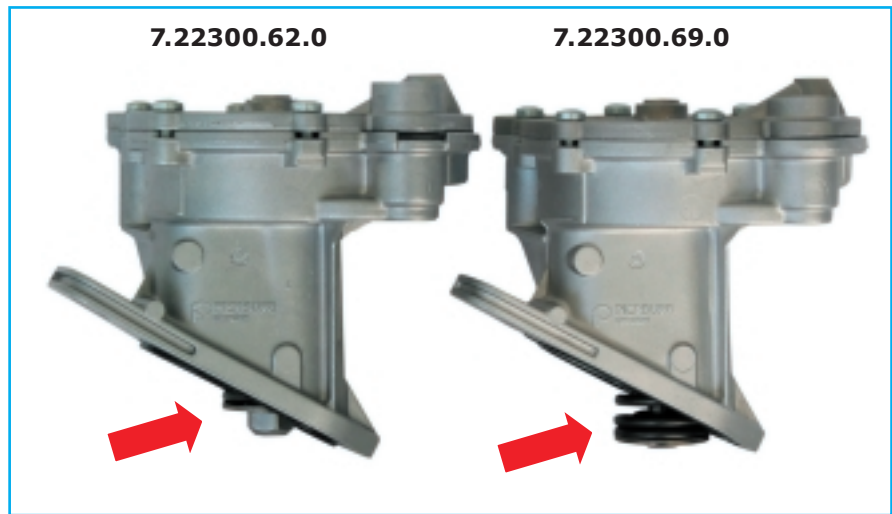
Fig. 2 Vacuum pump comparison

<b>7.22300.62.0</b>	<b>7.22300.69.0</b>
Replacement for:	7.22300.12.0	7.22300.19.0
Year of manufacture:	to 5/1994	from 5/1994
<b>Vehicle identification number:</b>	<b>to 70-R-180 000</b>	<b>from 70-R-180 001</b>
VW part number:	075 145 100 075 145 101 075 145 101 A	074 145 100 A
VW cylinder head No.:	074 103 351 A	074 103 351 D
MSI cylinder head No.:	50 003 101	50 003 113
Cylinder head cover surface:	11 bores; Ø 5mm	no bores
Pierburg tappet rod number:	3.52124.06.0	3.52124.05.0
VW tappet rod number:	075 145 307	074 145 307 B
Tappet rod length:	71.0 mm	67.5 mm

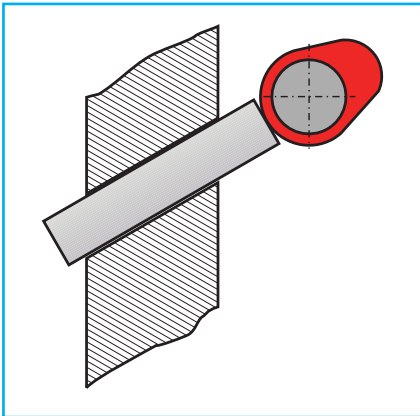
Fig. 3 Position of the camshaft during installation

During installation work the cam of the camshaft which drives the vacuum pump must be located at the opposite side of the intermediate tappet rod (see Fig. 3) so as to be able to install the pump under a slight pre-tension only (gap of 2 mm max.):

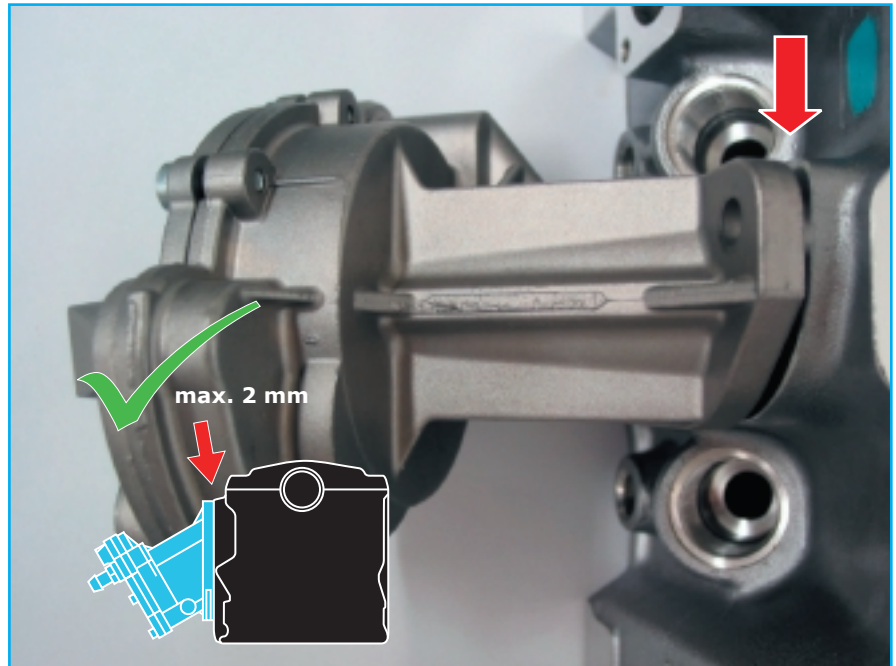
Fig. 4 Installation with correct assignment

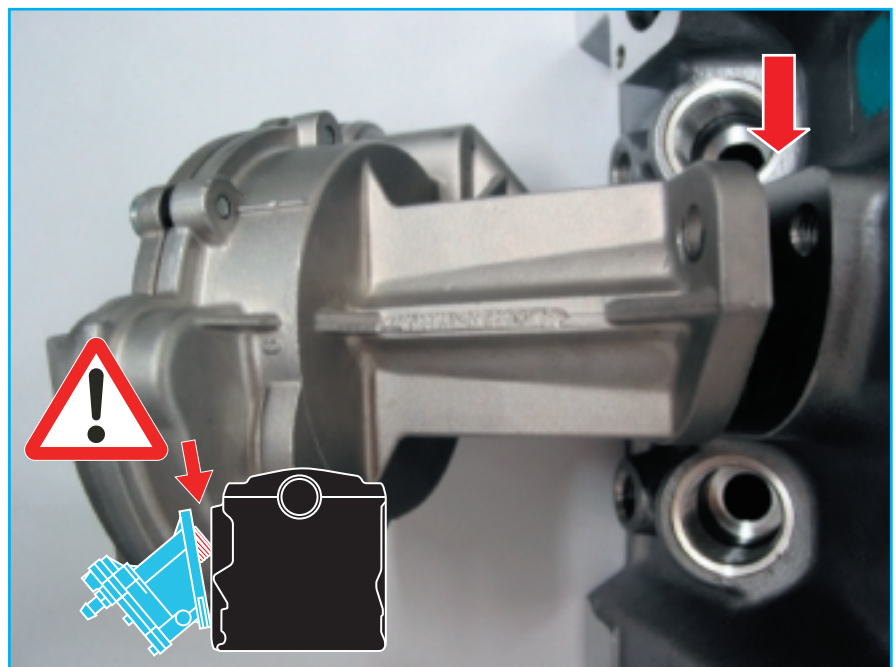
If the vacuum pump **cannot be pressed onto the flange without exerting a significant amount of force** (gap 5 mm approx.) although the cam is located at the opposite side of the intermediate tappet rod you can be sure that the **assignment is wrong**.

Fig. 5 In the case of a wrong assignment, proper installation will not be possible

- ⚠ Under all circumstances check
  - vehicle identification number
  - registration date and/or
  - part number of the old pump!

⚠ Never try to resolve this problem by modifying the intermediate tappet rod (by grinding, for example)
